**Investigating the Mechanism of Transgranular Stress Corrosion
Cracking in Near-Neutral pH Environments on Buried Fuel
Transmission Pipelines**

A Dissertation
Presented to
The Academic Faculty

Georgia Institute of Technology
December 2007

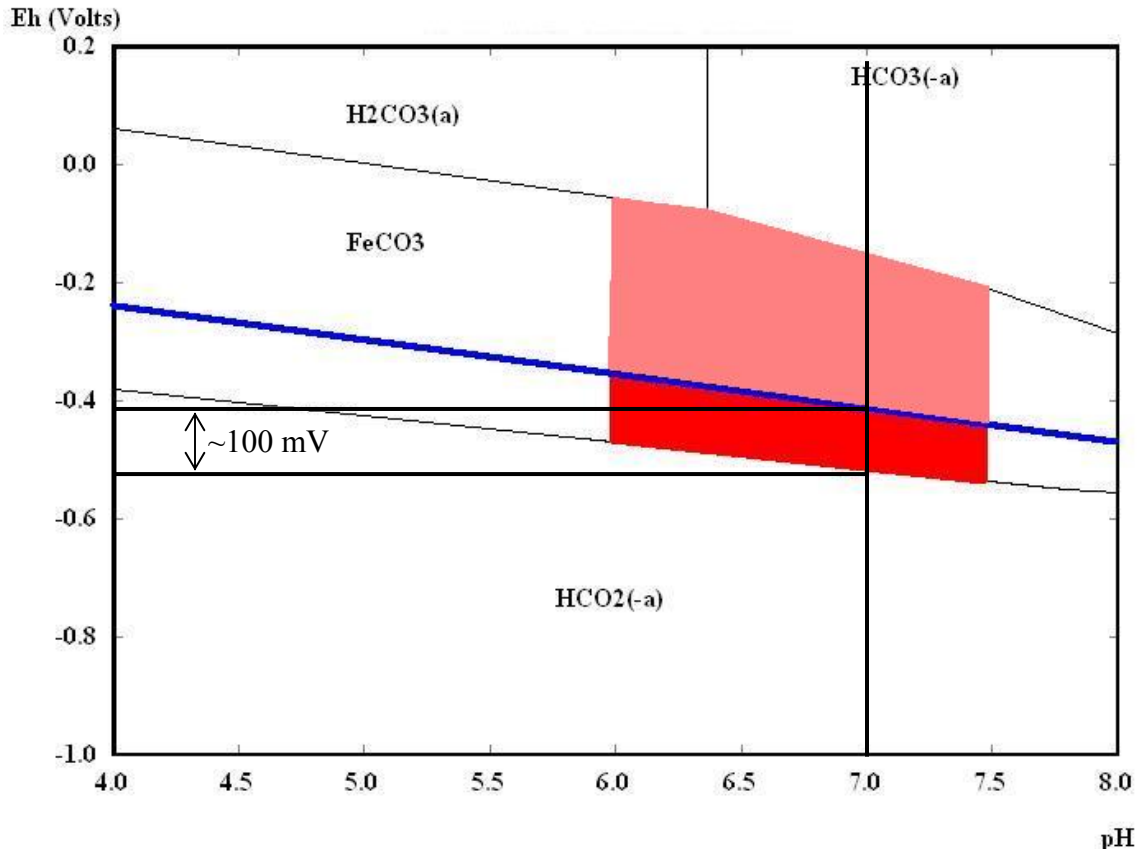
Figure 47 -Pourbaix diagram of Fe-C- H₂O showing the region of NNPHG feasibility for pipeline steel at 25°C. The red area is where both NNPHG hydrogen and cathodic hydrogen can be feasible. The pink region is where only NNPHG hydrogen is possible.

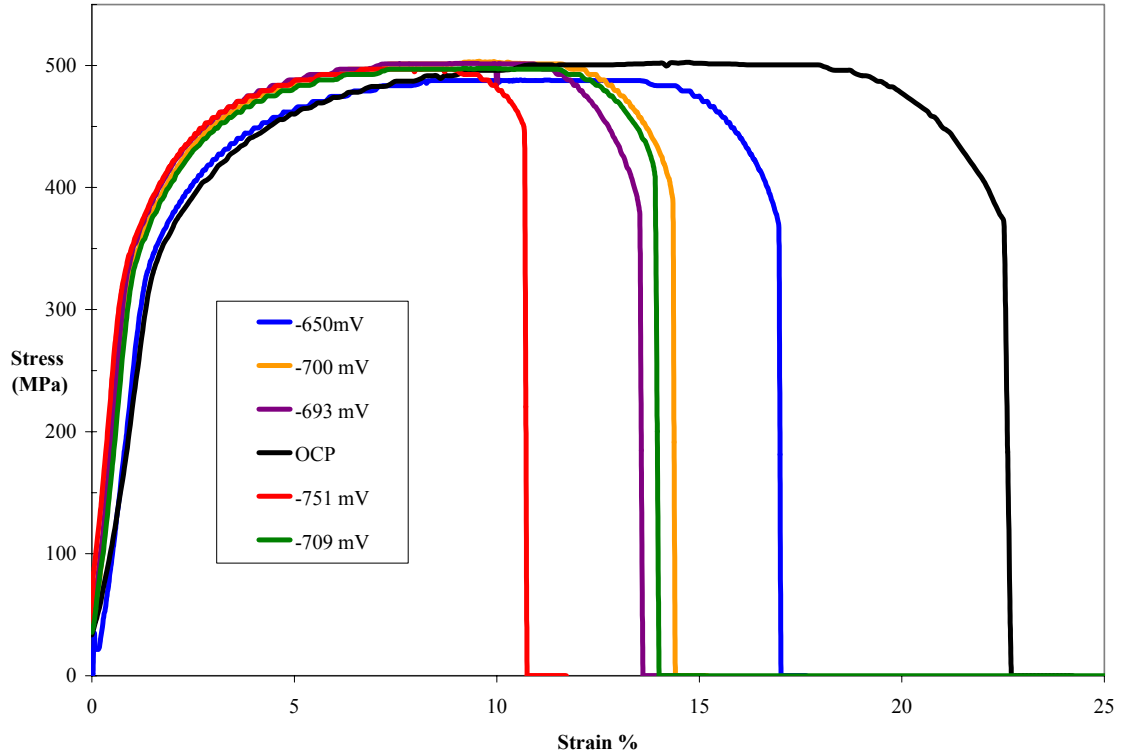
Figure 48 - Stress-Strain behavior of pipeline steel samples subjected to slow strain rate testing in 0.5 g/L NaHCO₃ with 5% CO₂ at room temperature and given applied anodic potentials. Note drastic decrease in mechanical properties with a small anodic potential

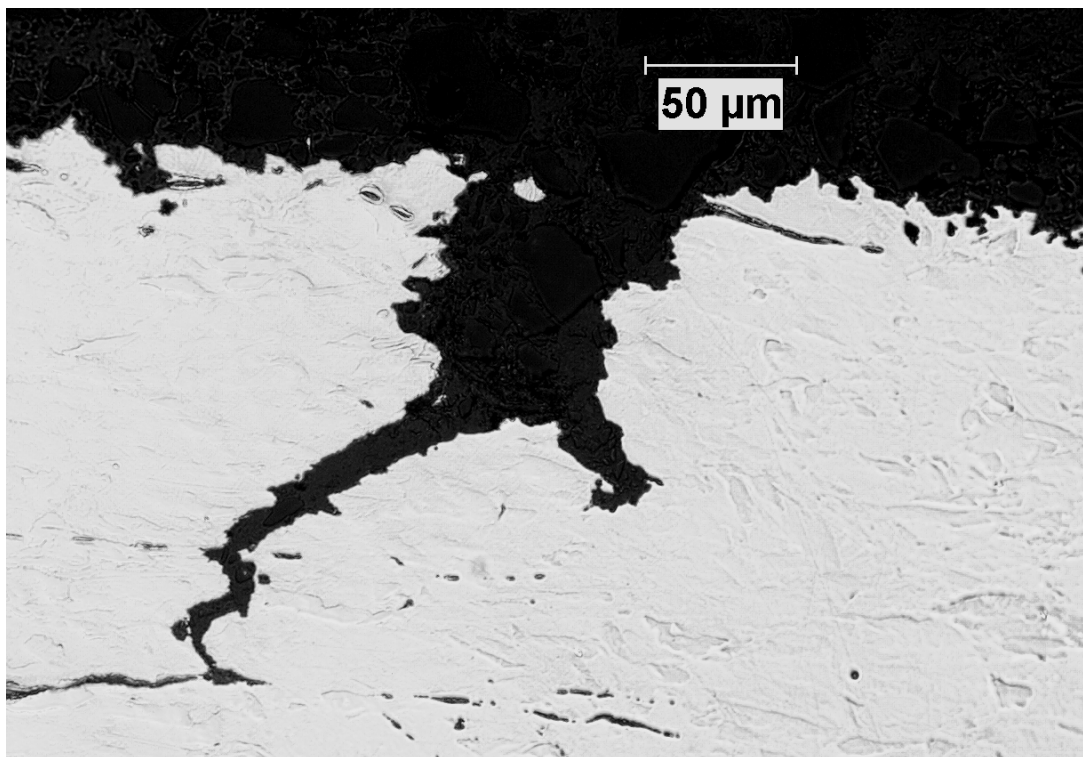
Figure 49 - TGSCC crack formed on smooth slow strain rate sample exposed to 0.5 g/L NaHCO₃ with 5% CO₂ at room temperature and 20mV anodic potential from OCP

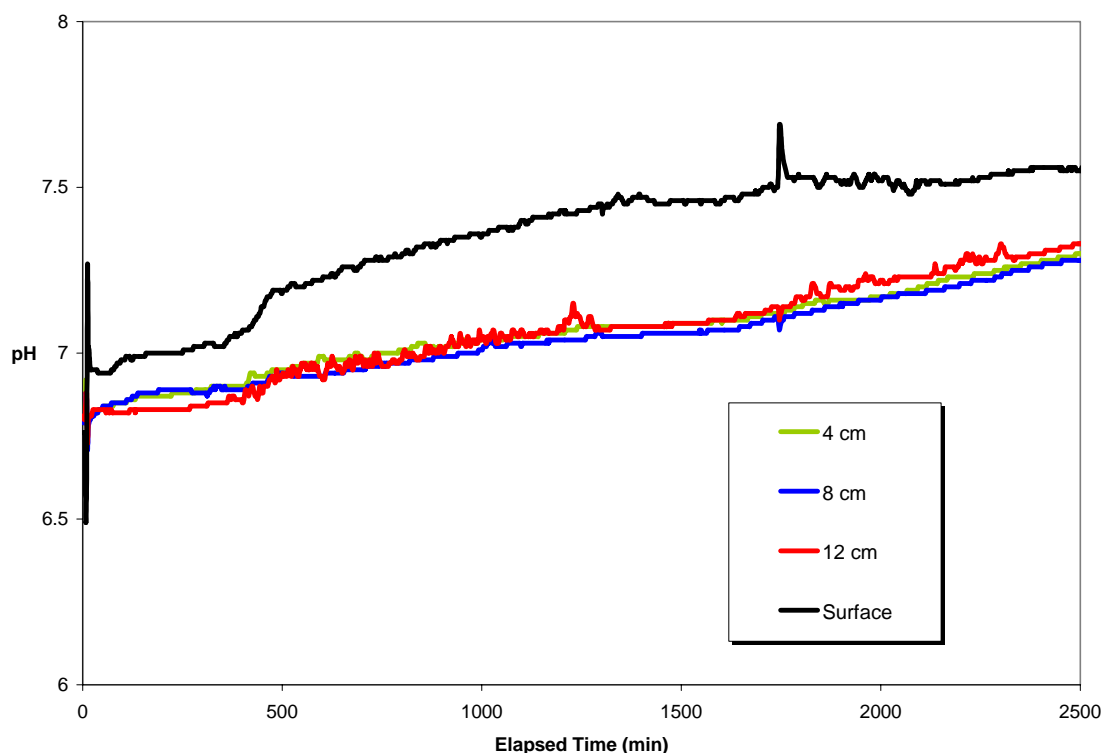
Figure 50 - pH vs. Time profile for 0.5 g/L NaHCO₃ solution saturated with CO₂ at -750mV. Note that surface pH is greater than the bulk solution. However, the surface pH does maintain near-neutral conditions for the majority of the test, especially during the initial time when CO₂ is most available.

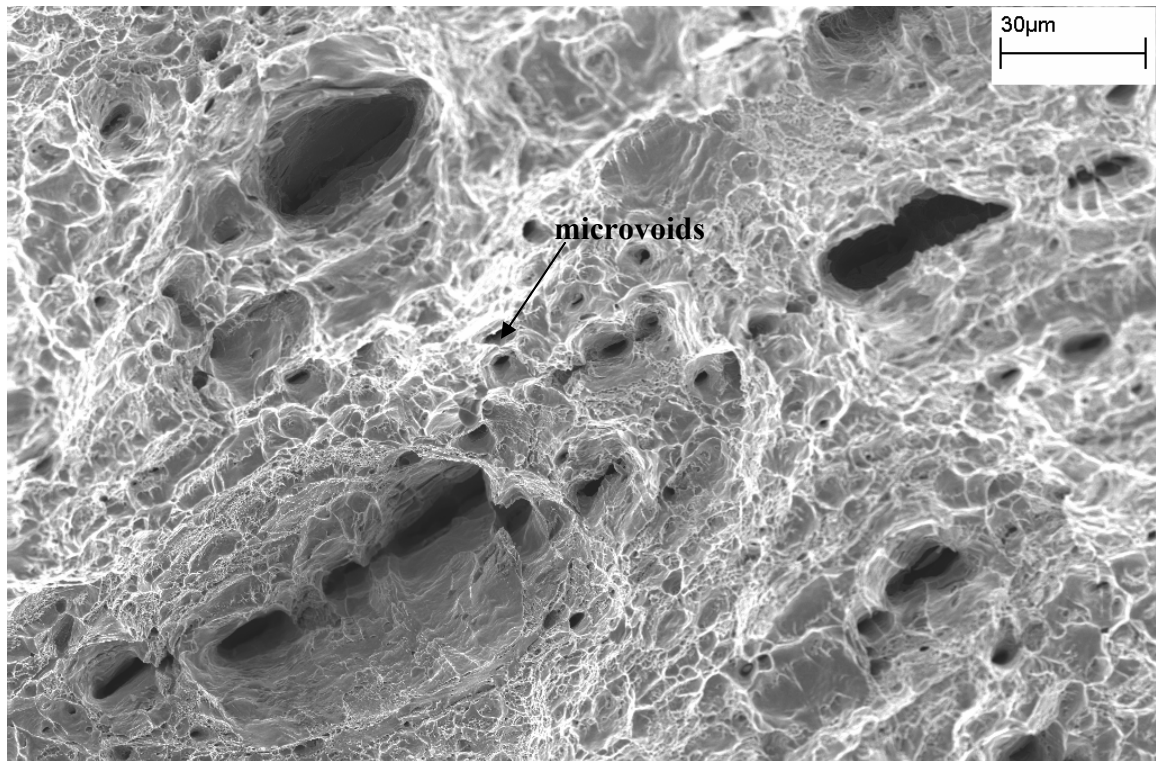
Figure 51 - Fracture surfaces of notched slow strain rate samples imaged at 500X for notched sample strained in air. Note the dimpled surface and formation of microvoids.

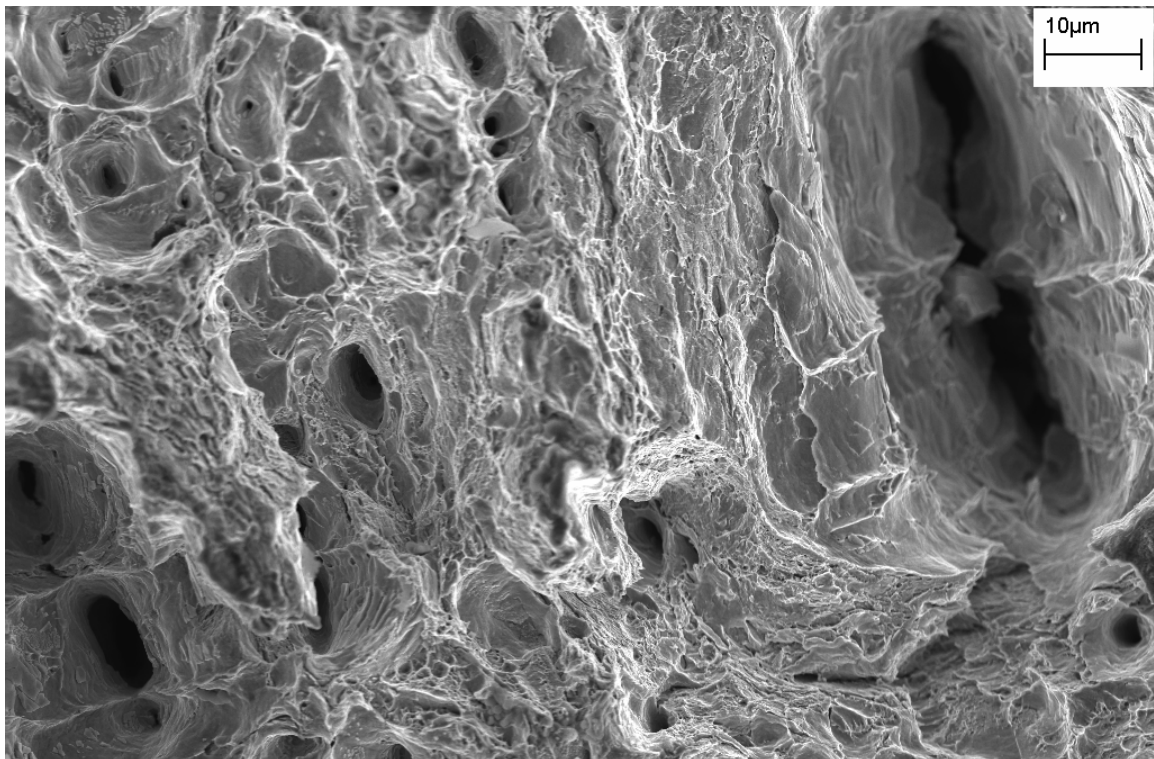
Figure 52 - SEM image of fracture surface of notched sample continuously strained in 0.5g/L NaHCO₃ with 5%CO₂ at room temperature and at OCP. Sample exhibits the same dimpled surface as the sample exposed to air.

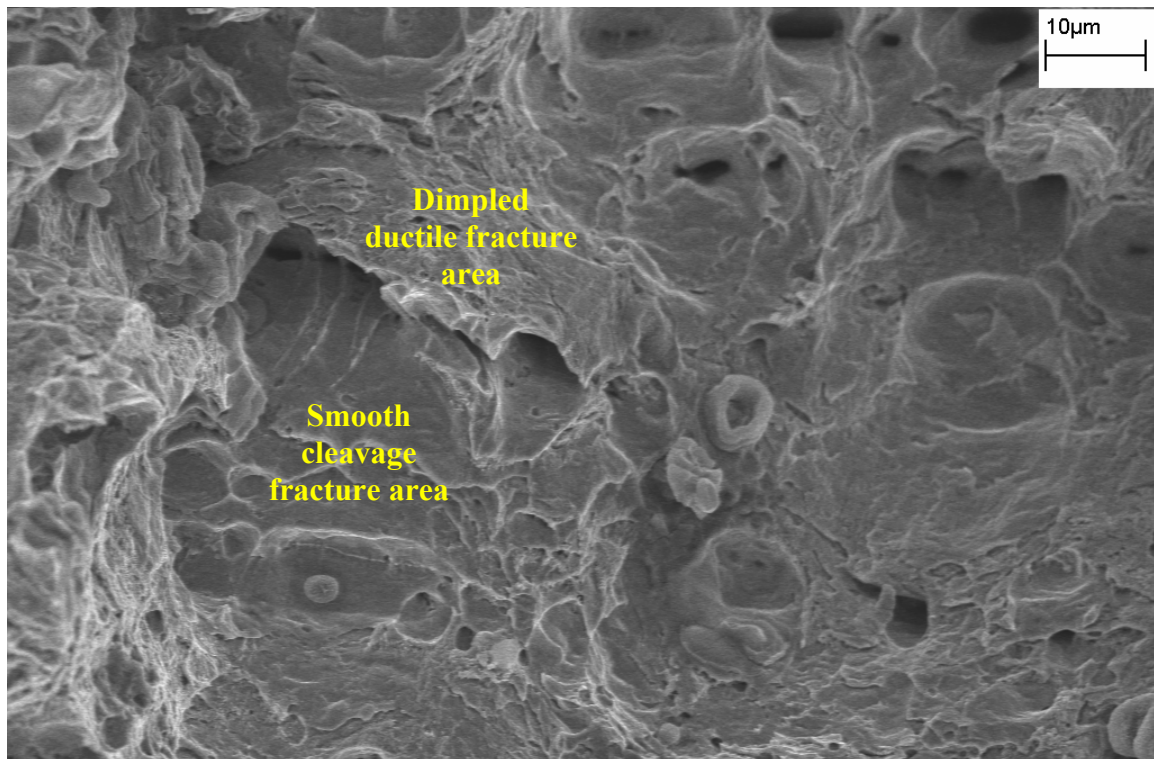
Figure 53 - SEM image of fracture surface of notched sample exposed to 0.5g/L NaHCO₃ with 5% CO₂ at room temperature and OCP and held at 85% yield strength for 15 days. This surface has a large area of smooth cleavage surfaces along with areas of dimpling.

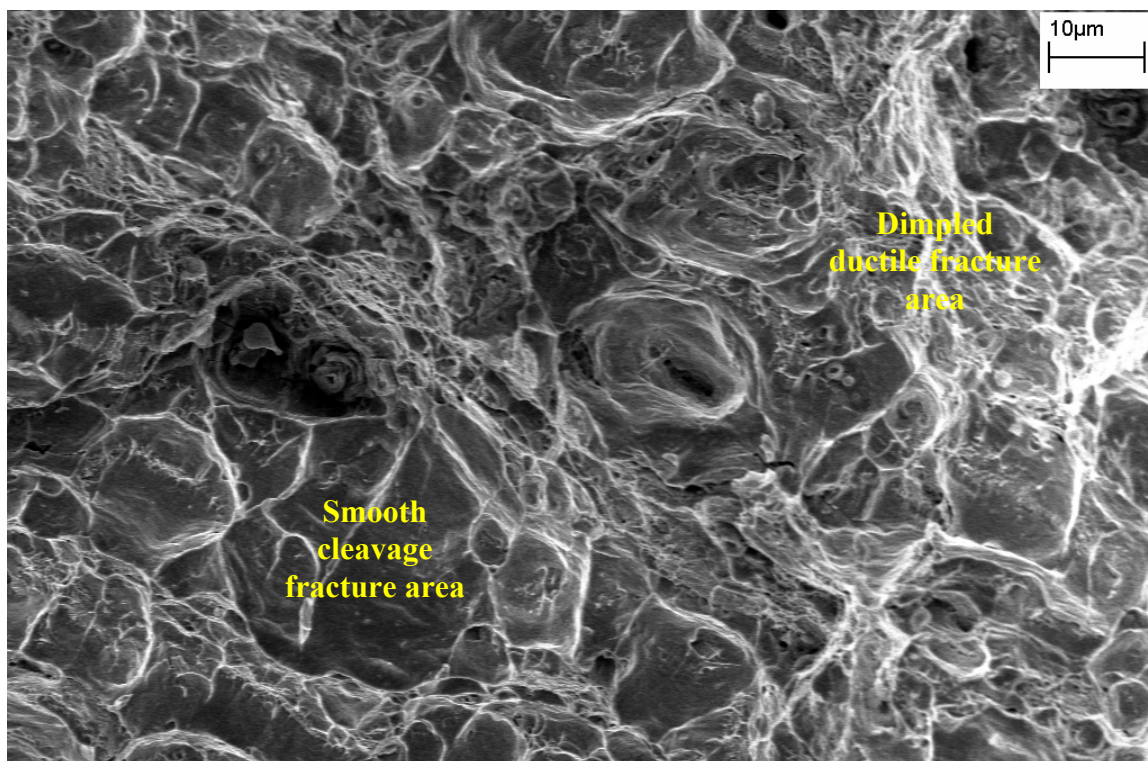
Figure 54 - SEM image of fracture surface of notched sample exposed to 0.5g/L NaHCO₃ with 5% CO₂ at room temperature and OCP and held at 85% yield strength for 30 days. Sample surface is primarily smooth indicating a cleavage fracture, with small areas of dimpling indicating ductile tearing between brittle regions.

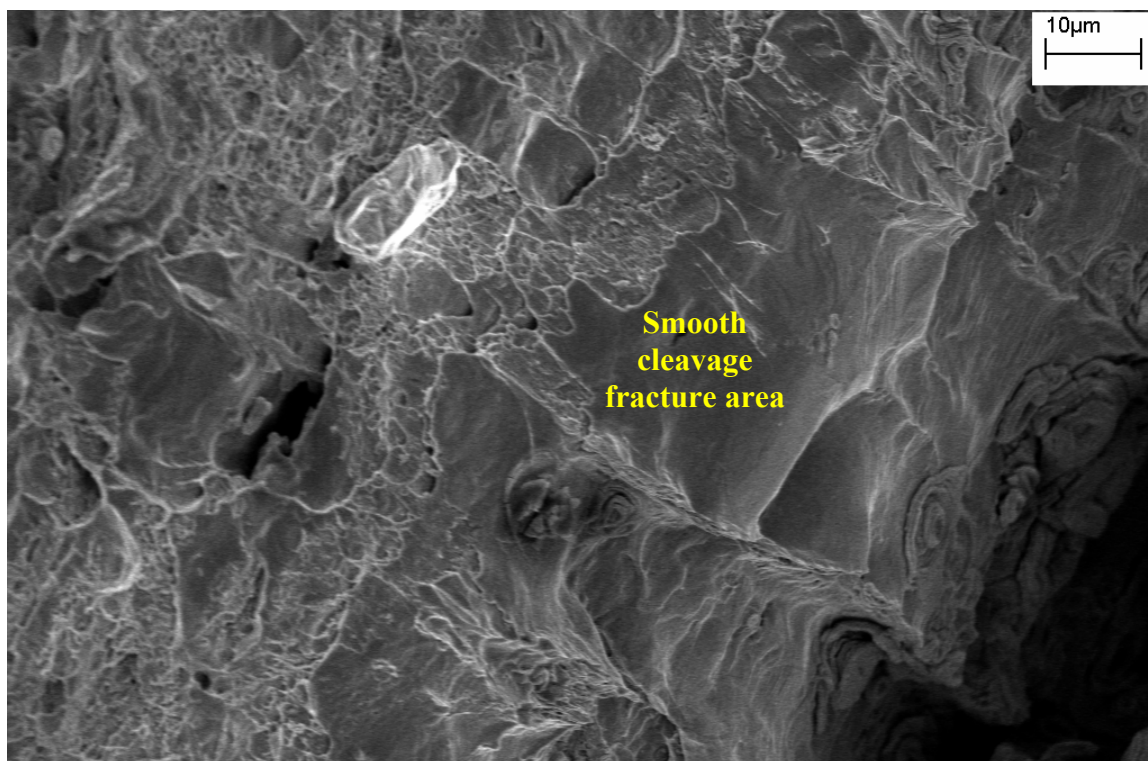
Figure 55 - Fracture surface of notched sample exposed to 0.5g/L NaHCO₃ with 5% CO₂ at room temperature and -1V_{SCE} during continuous straining. Note the large areas of cleavage that is similar to 30 day load hold sample.

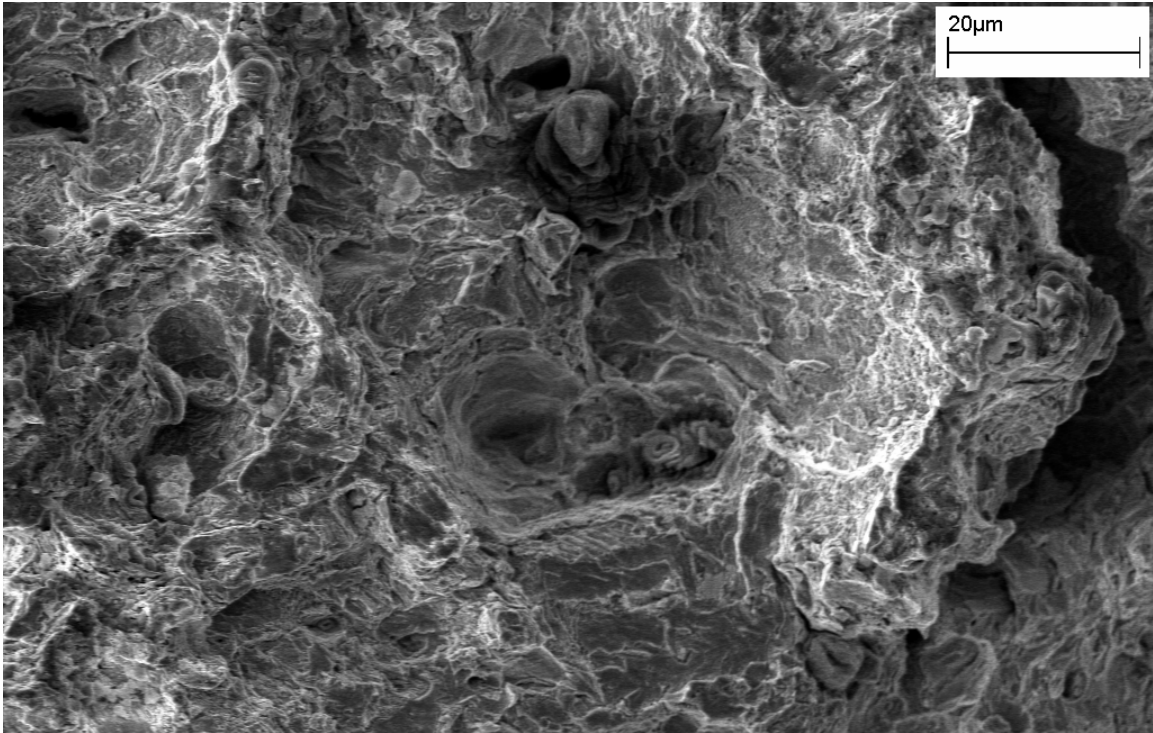
Figure 56 - SEM image of fracture surface of $-1V_{SCE}$ pre-charged notched sample. This image is taken near the notch edge. The fracture surface has significant dimpling and very little cleavage area, indicating a ductile fracture.

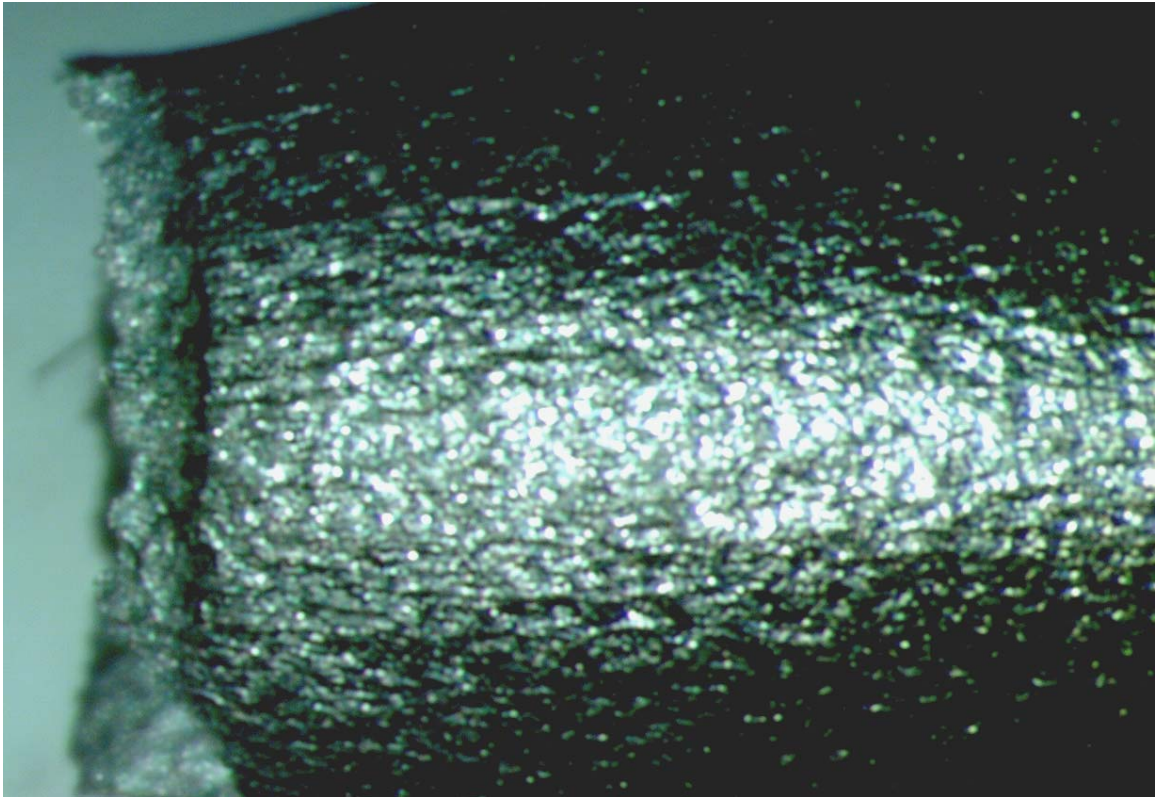
Figure 57 - Slow strain rate sample gauge of sample 5% pre-strained and then strained to failure in dry air

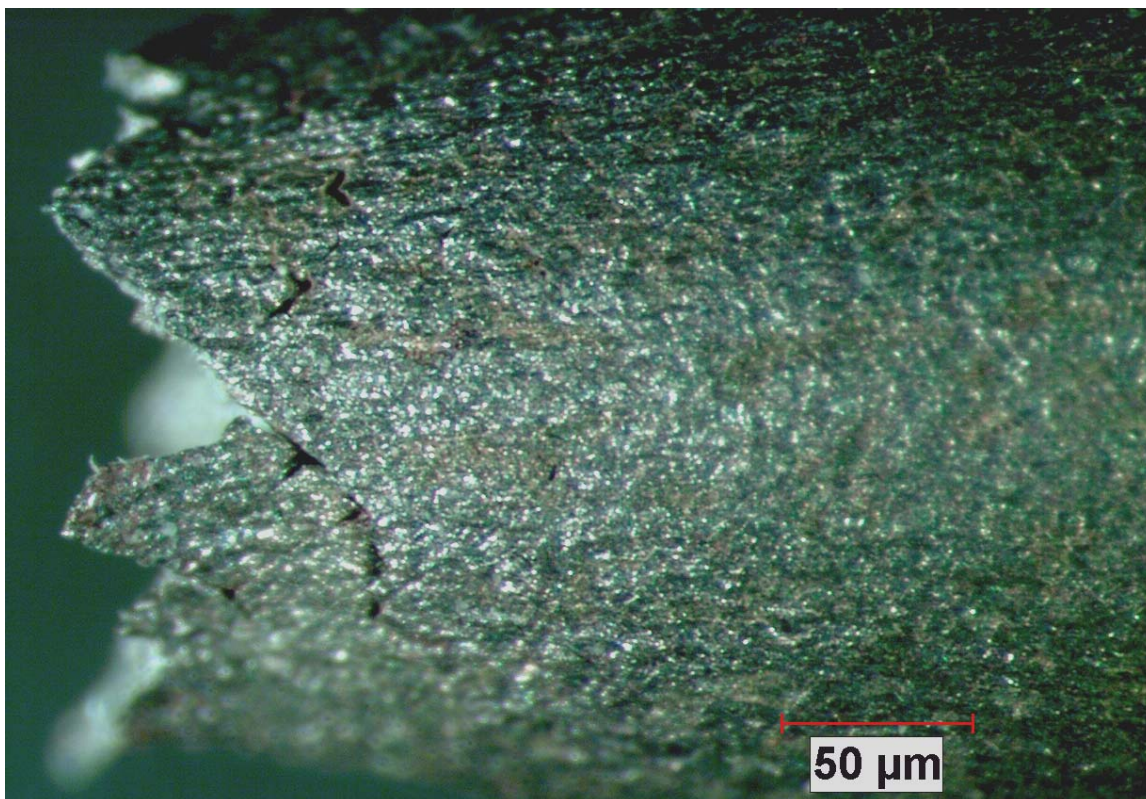
Figure 58 - Slow strain rate sample gauge of sample 5% pre-strained and then strained to failure in TGSCC environment

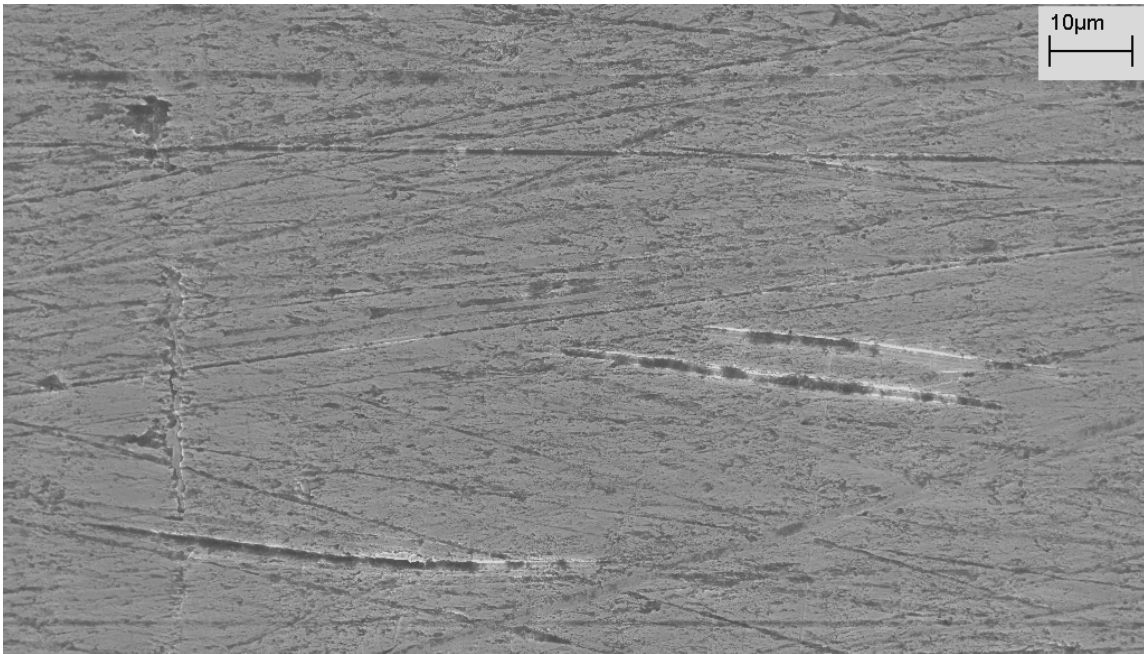
Figure 59 - Sample surface after loading to one-third the yield strength. This image shows the preferential dissolution at scratches that were created during sample preparation.

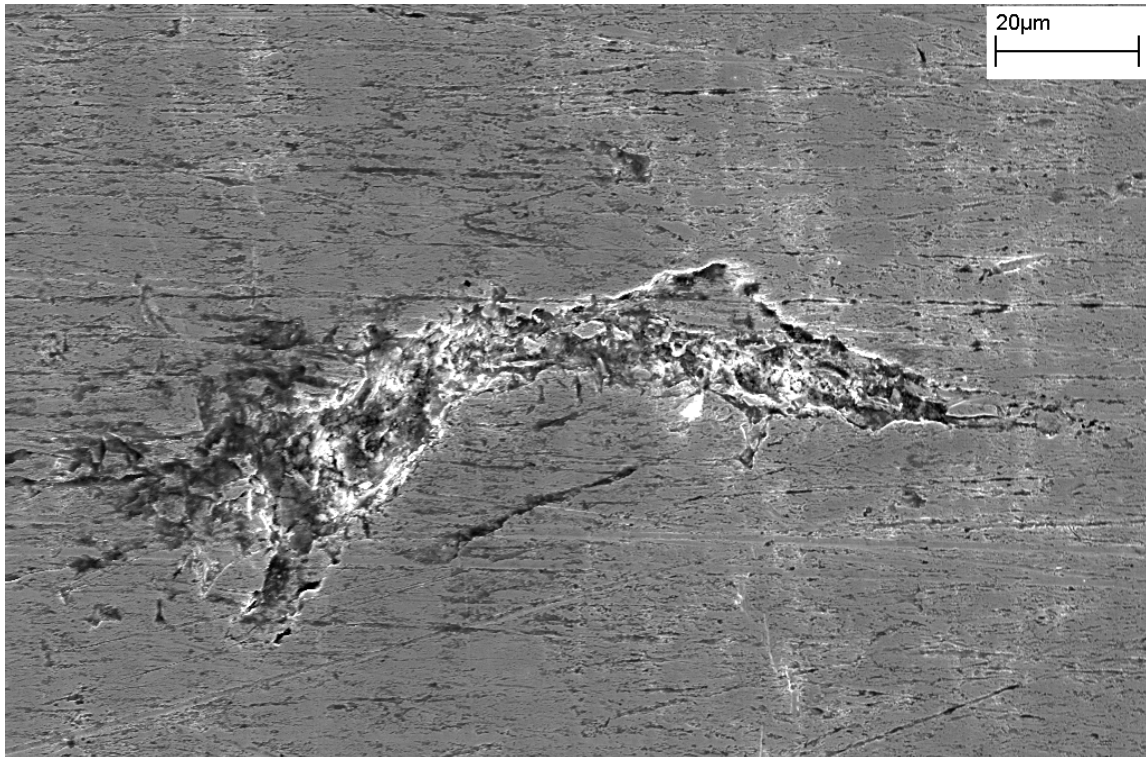
Figure 60 - Site of inclusion dissolution to produce crack like feature at loading to one-third yield strength

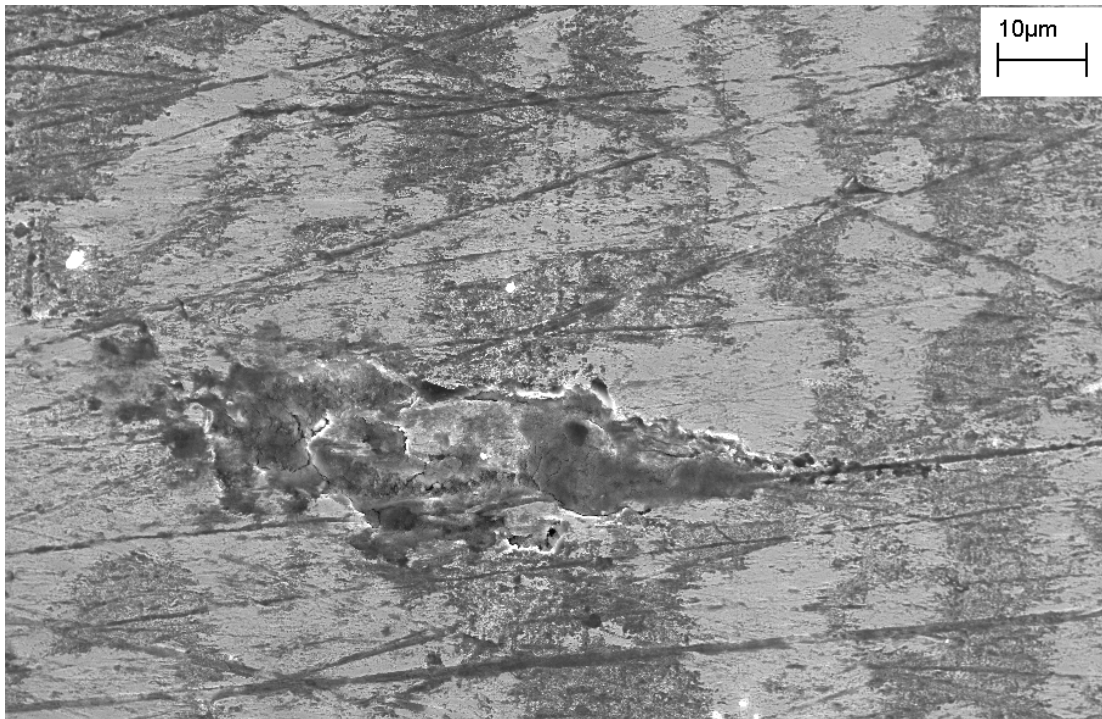
Figure 62 - Dissolution around smaller inclusions at the pipeline surface. Note the mud-like cracking that occurs on the internal surface of the inclusion.

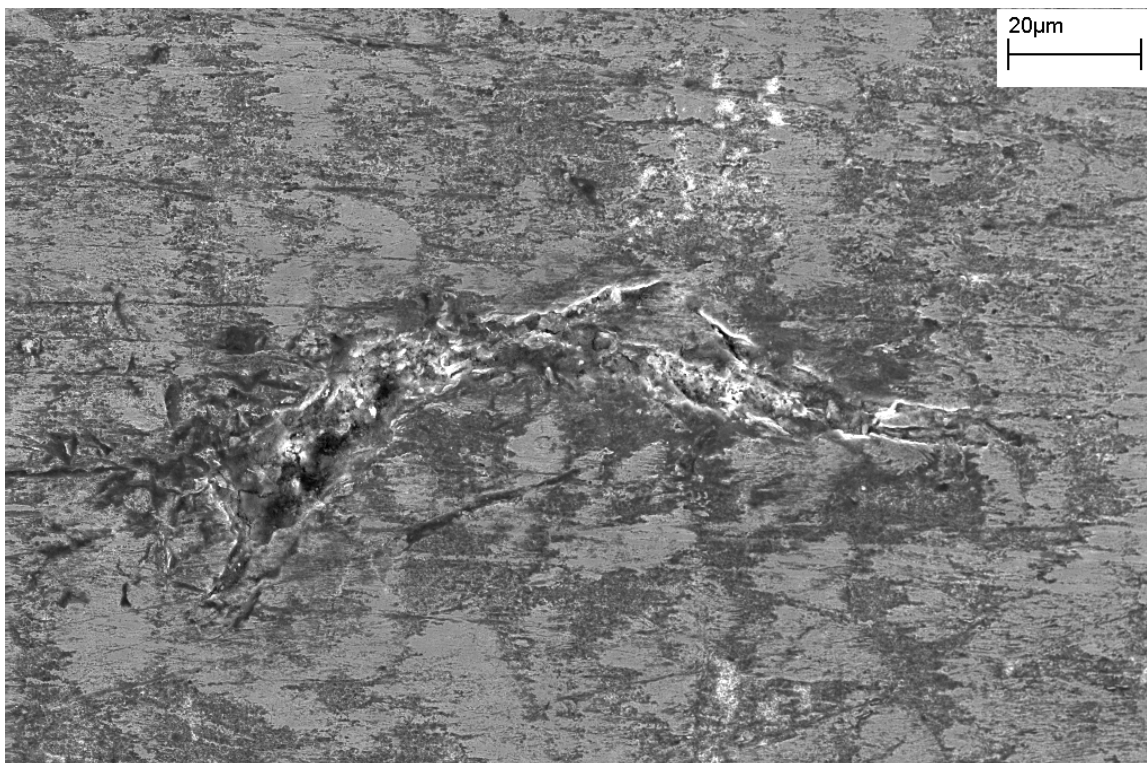
Figure 63 - Continued growth of the feature shown in Figure 60

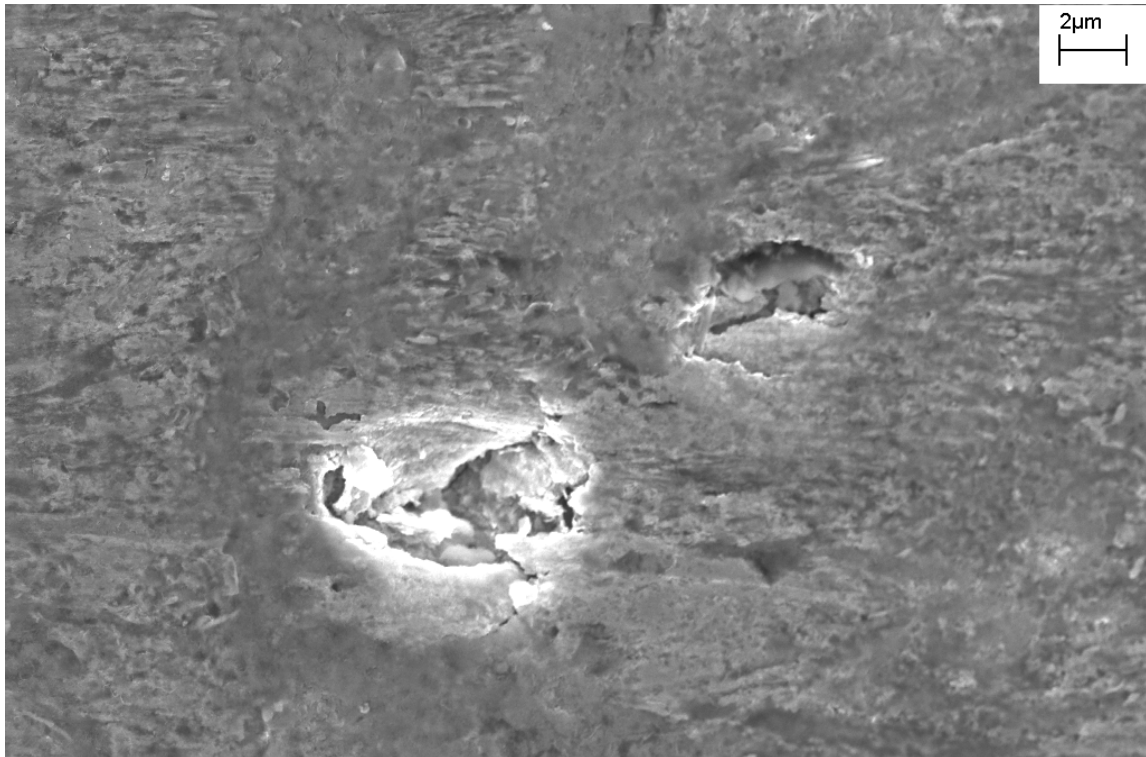
Figure 64 - Pits formed by small inclusions falling out of the sample surface

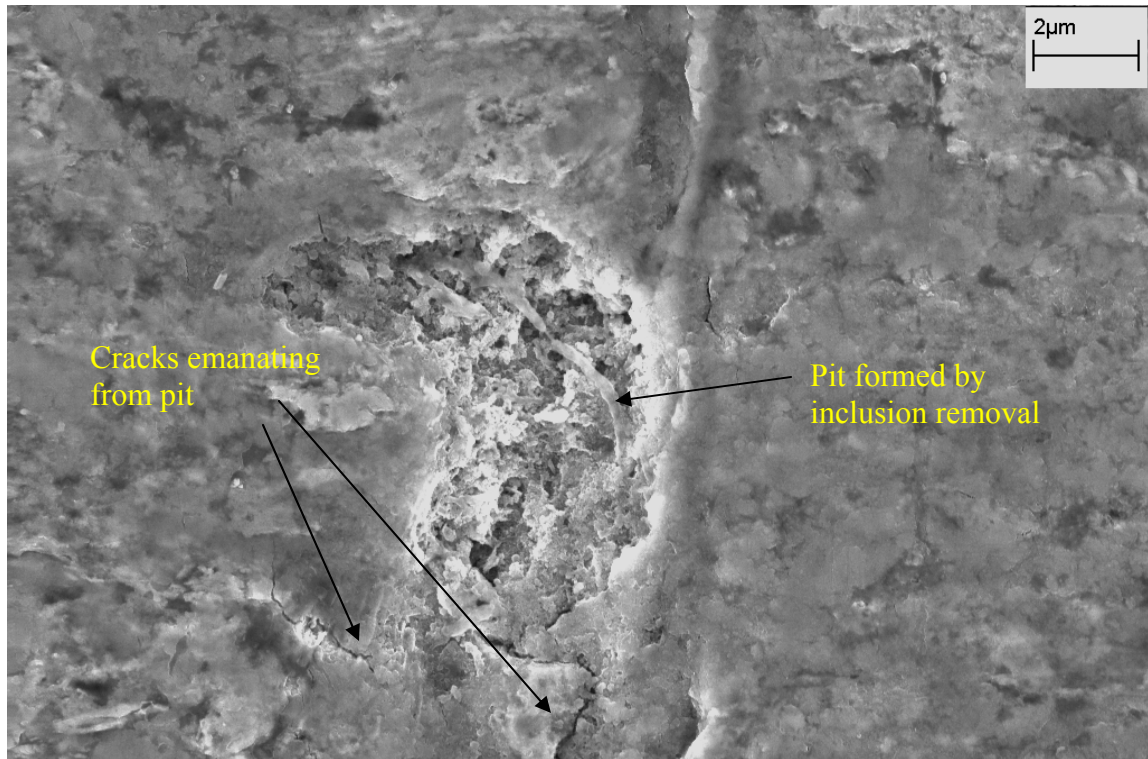
Figure 65 - Pit that has developed a crack that propagated into the pipeline steel. This occurred just after yield stress.

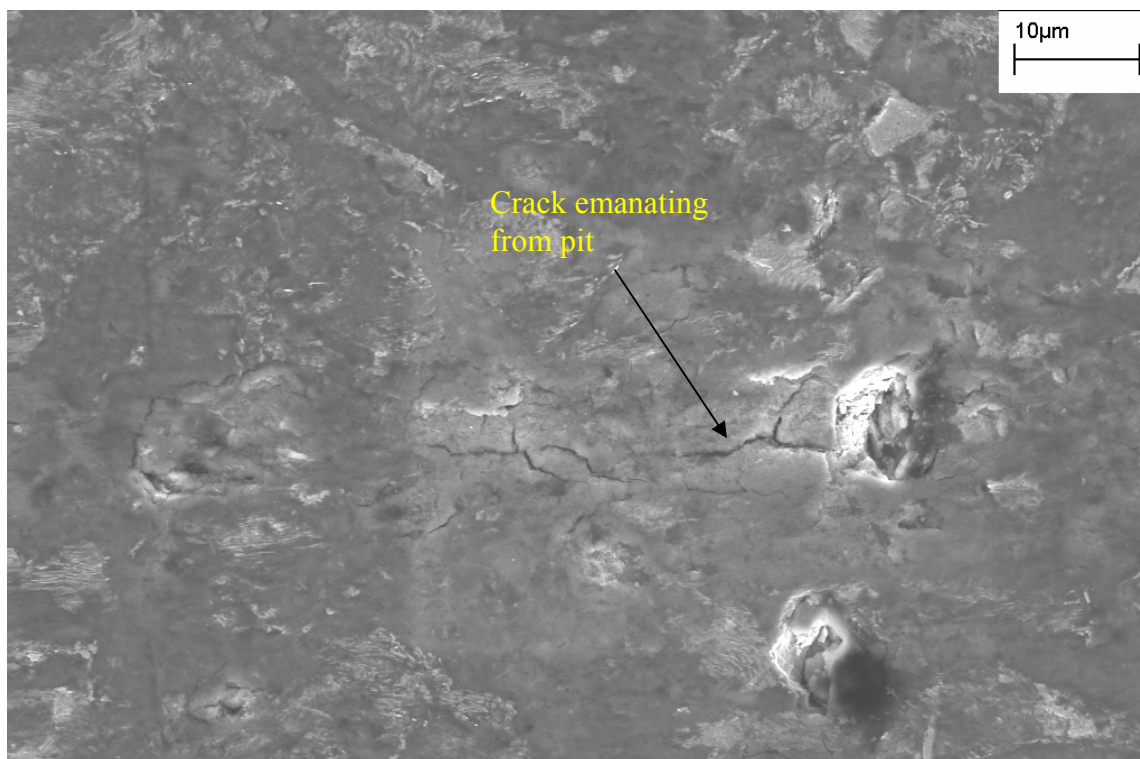
Figure 66 - Image of cracks originating from pits on the surface during interruption after 410 MPa of load.

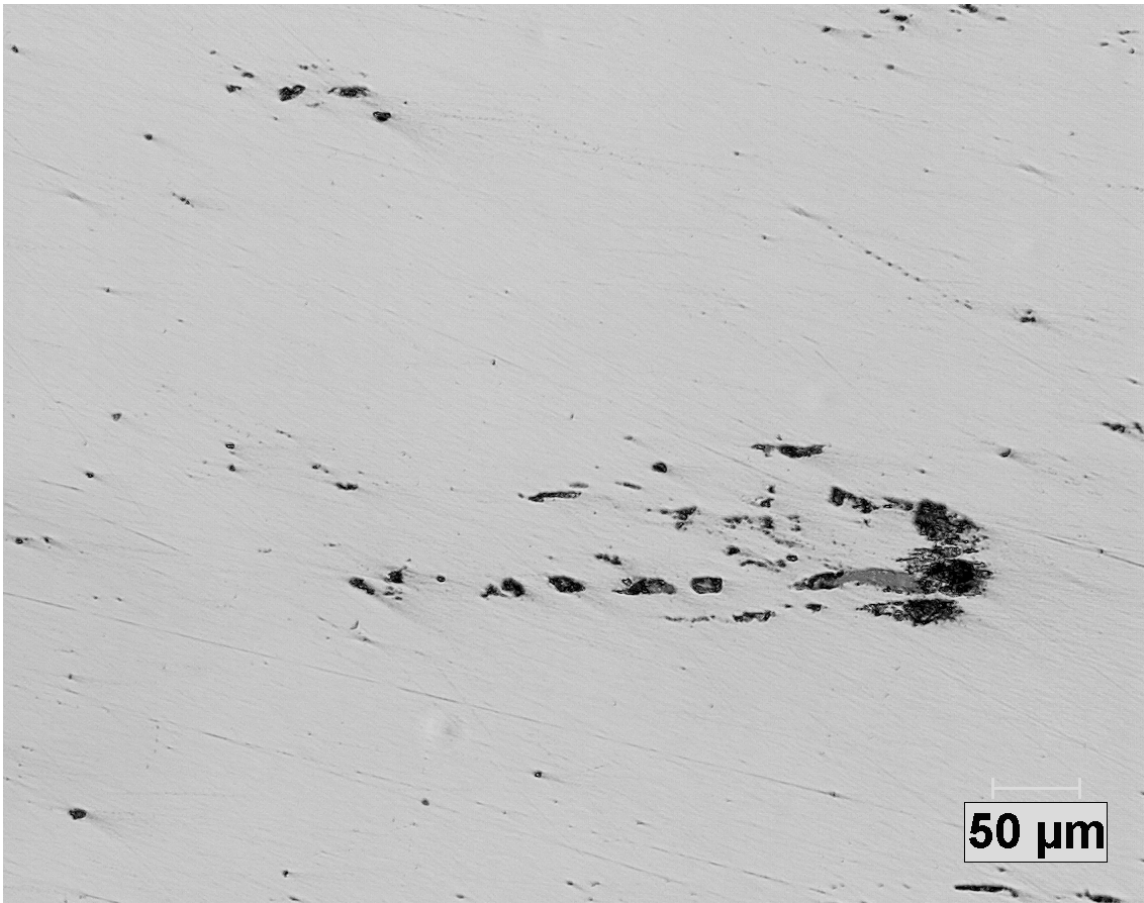
Figure 67 - Pipeline steel imaged prior to exposure to TGSCC environment. The surface was polished to 0.05 micron to reveal inclusions, which are the dark regions on the surface.

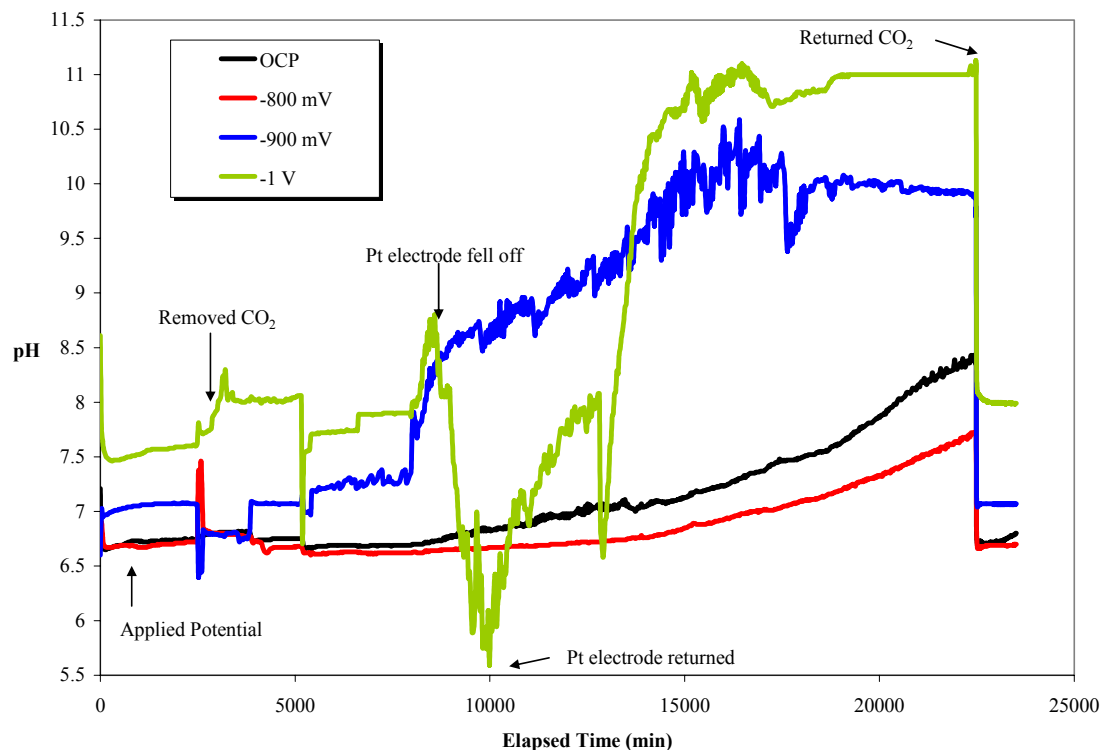
Figure 71 - pH vs. Time for 0.5g/L NaHCO₃ Solution at 15°C and 5% CO₂ for varying levels of cathodic protection.

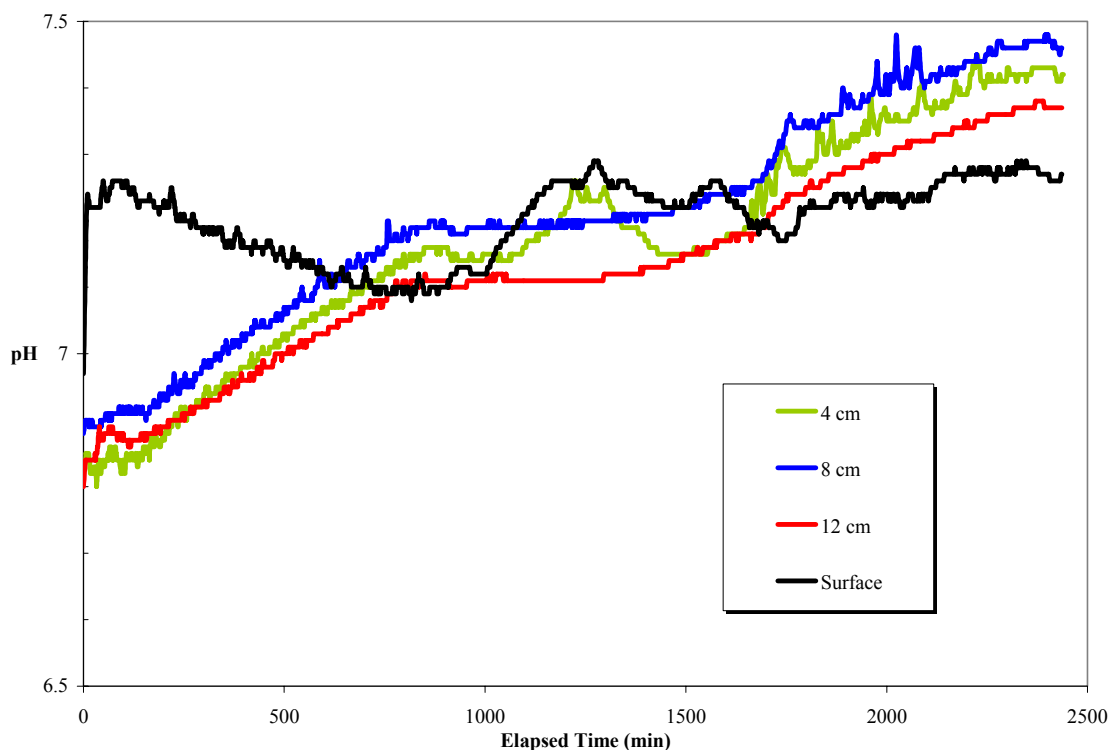
Figure 72 - pH at the X-65 pipeline steel surface as well as at different distances away from the surface as a function of time for 0.5 g/L NaHCO₃ solution saturated with CO₂ under open circuit potential (-780mV_{SCE}).

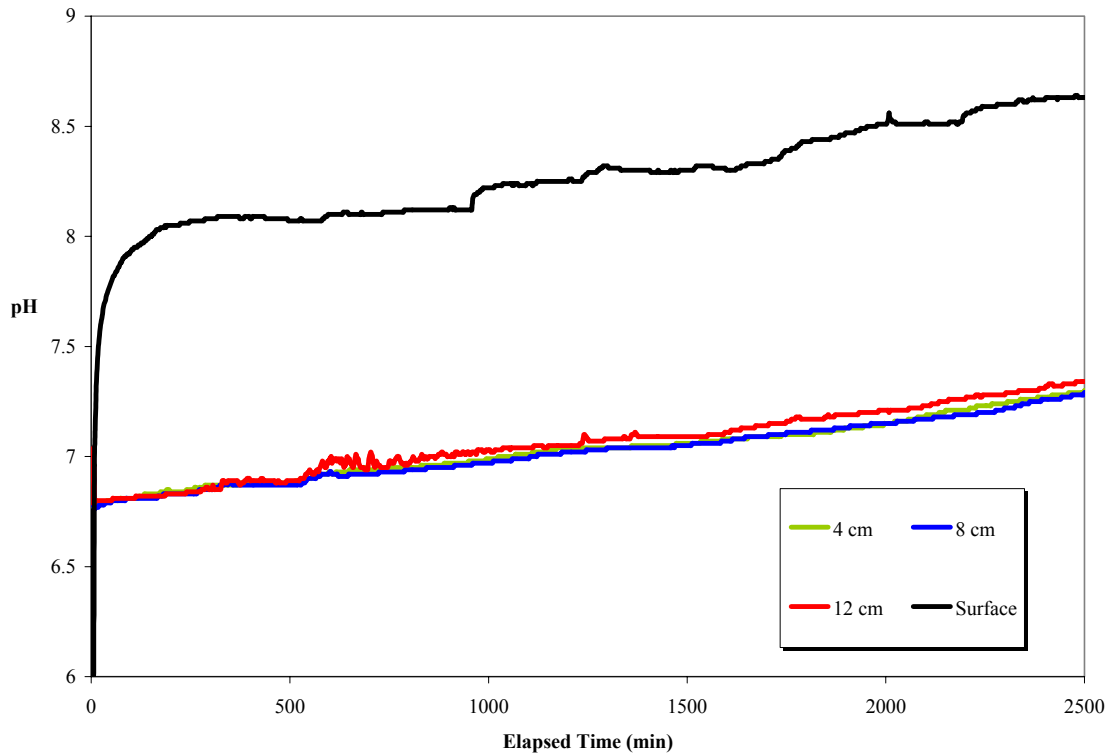
Figure 73 - pH at the X-65 pipeline steel surface as well as at different distances away from the surface as a function of time for 0.5 g/L NaHCO₃ solution saturated with CO₂ with applied potential of -800mV_{SCE}. Note that surface pH rapidly increases and is not near-neutral almost immediately.

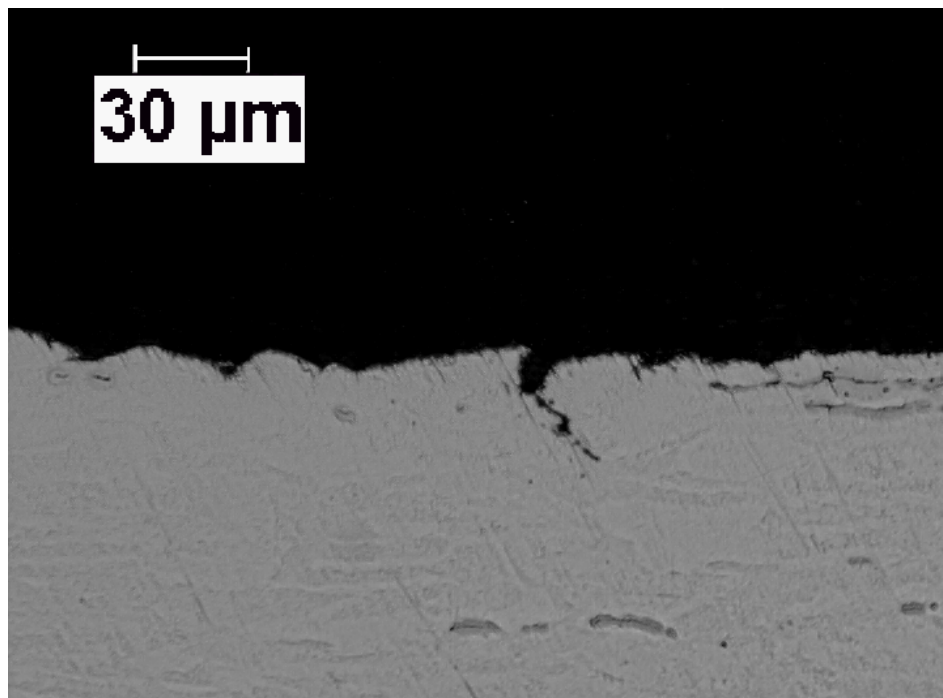
Figure 79 - Crack morphology for samples exposed to 0.5 g/L NaHCO_3 with 0.122g/L KCl with 5% CO_2 at room temperature and OCP.

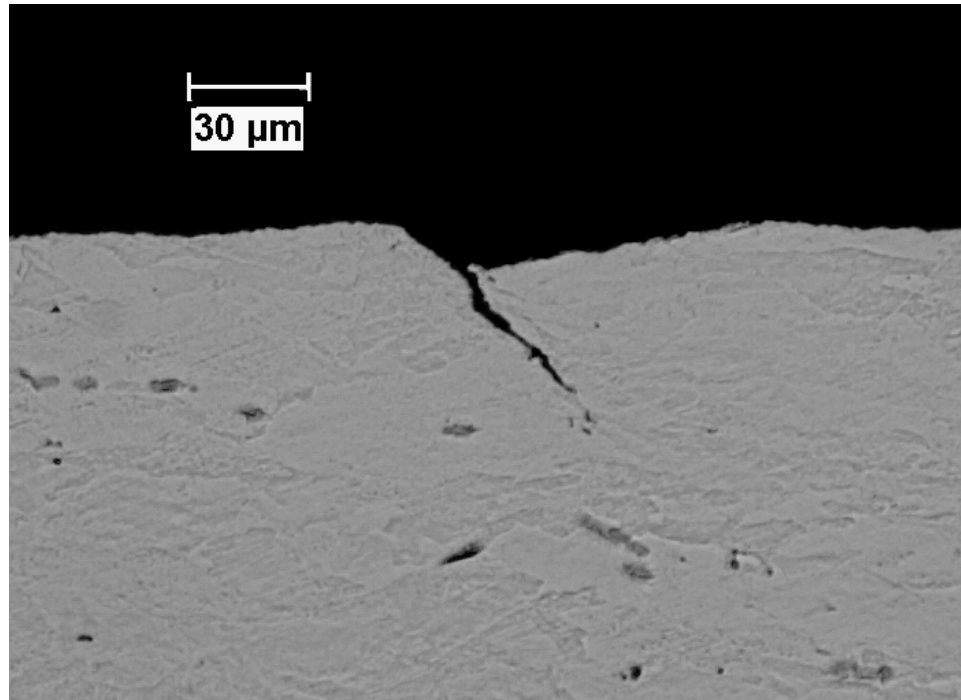
Figure 80 - Crack morphology of sample exposed to 0.5 g/L NaHCO₃ with 0.137 g/L CaCl₂ with 5% CO₂ at room temperature and OCP
